EMR Shielding of single level home from 3G mobile phone tower

Project carried out by EMR Shielding Solutions using HSF-54 shielding paint and fabric.

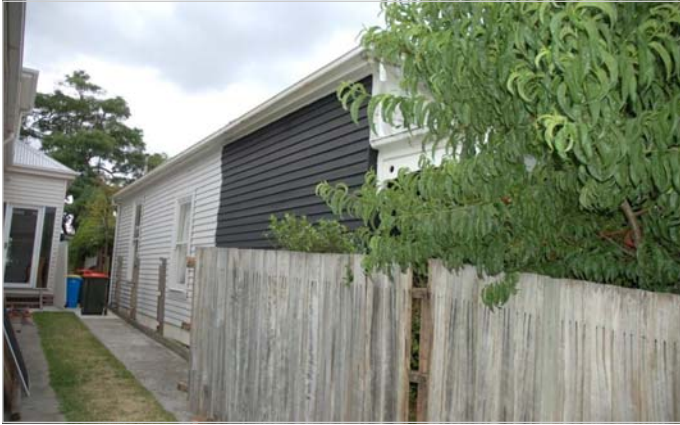
1) Shielding paint begins to be applied only on affected areas.

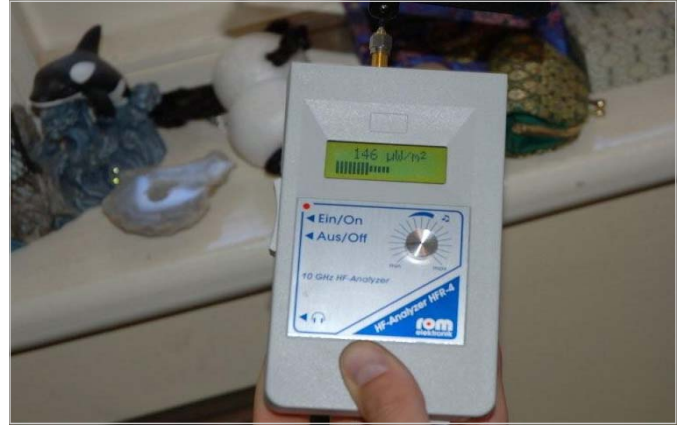
2) High reading of 146 microwatts per metre squared in child's bedroom in front of house.

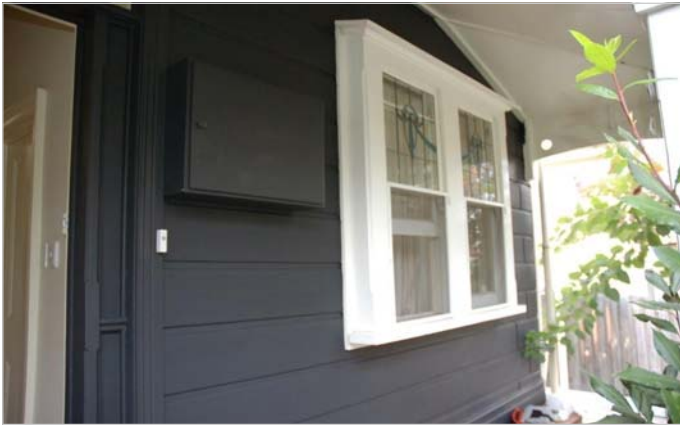
3) Front of house shielded with HSF-54 shielding paint.

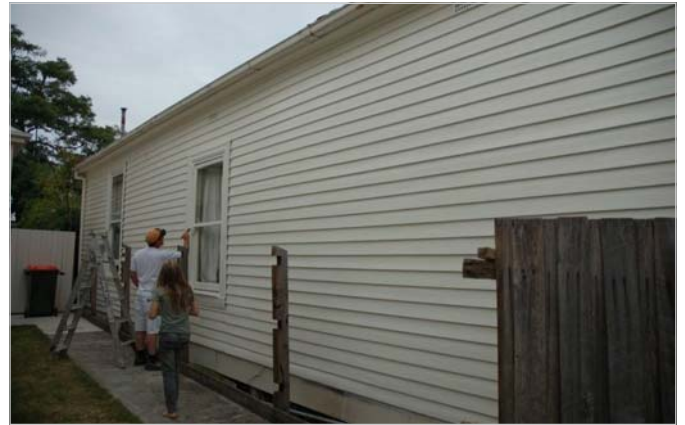
4) Over painting is easy with two coats of normal exterior paint.

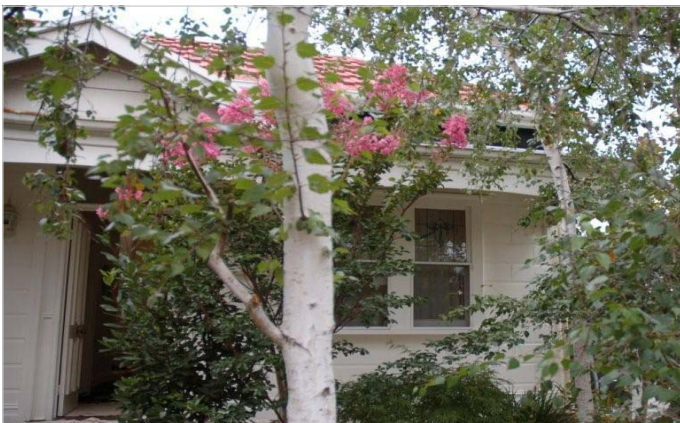
5) Inside of child's bedroom windows at front of house shielded with Eco 30 shielding fabric.

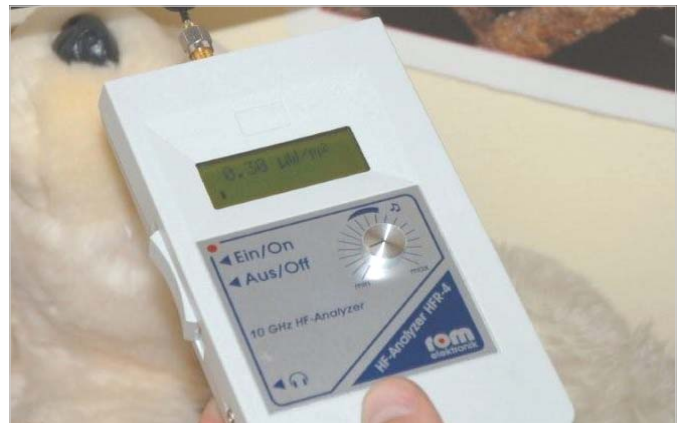
6) Child's bedroom now only reading 0.30 microwatts per metre squared after shielding.

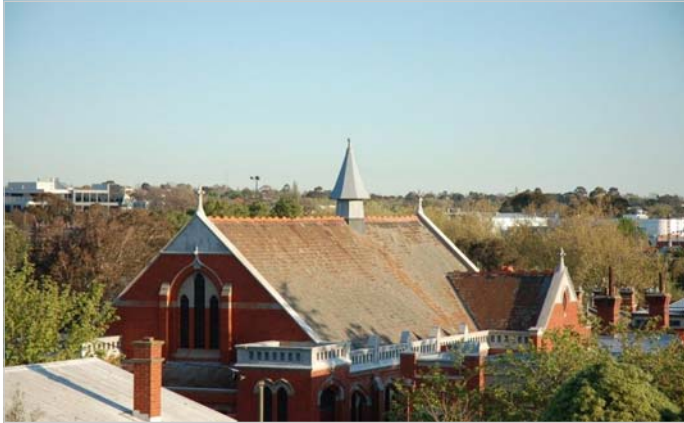
1) 3G Mobile phone tower hidden in church spire.

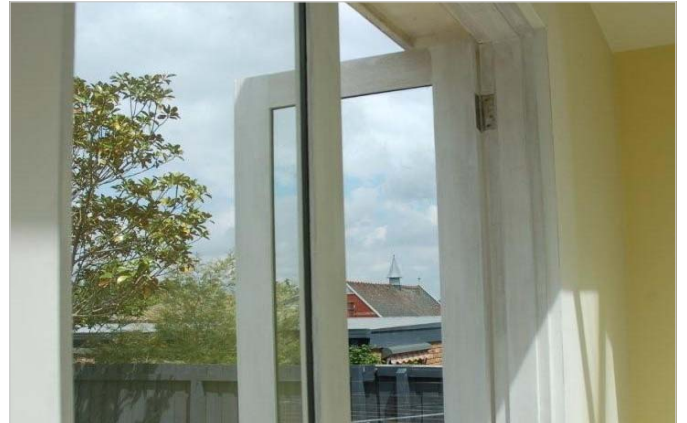
2) Mobile phone tower visible only 60m from family room.

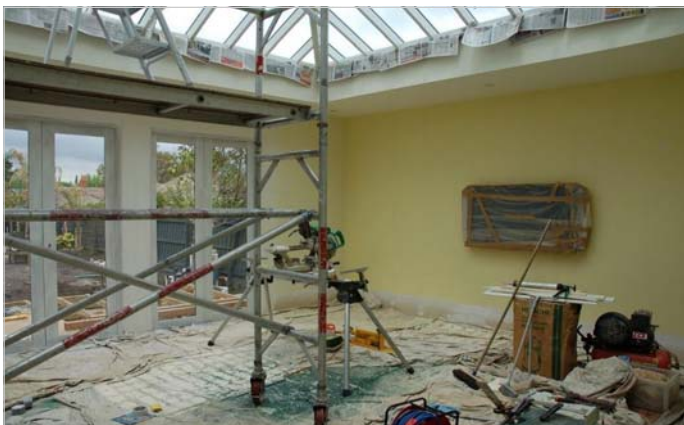
3) Room being prepared for shielding paint application.

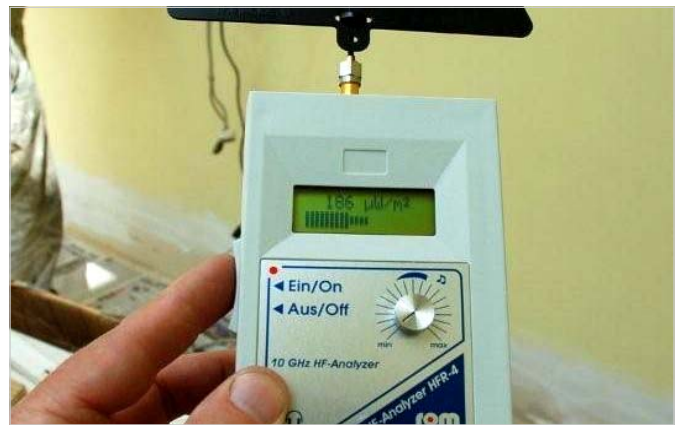
4) High reading of 186 microwatts per metre squared pre shielding.

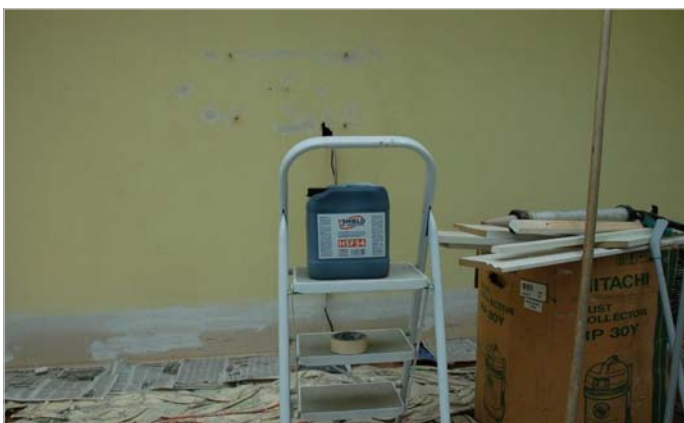
5) Shielding paint about to be applied.

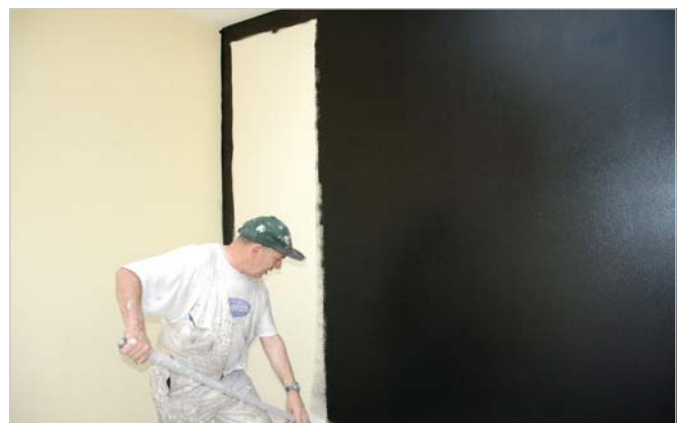
6) Shielding paint is applied.

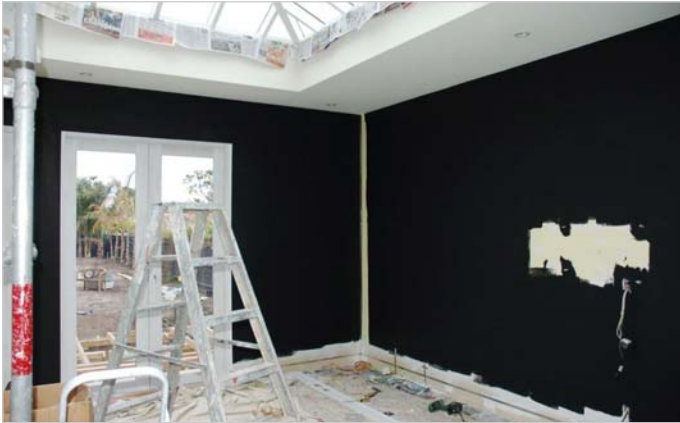
7) Shielded room.

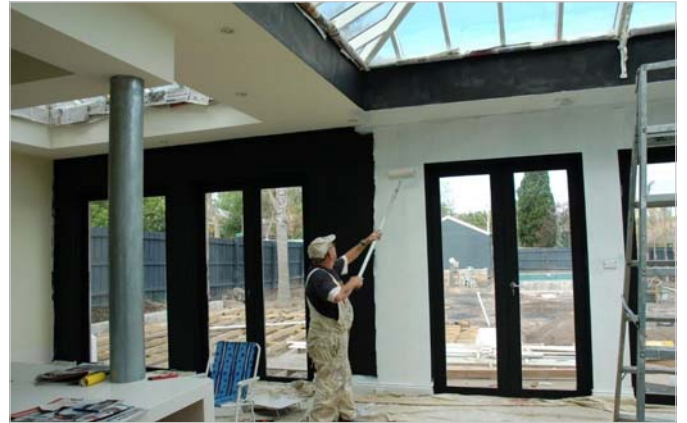
8) Two quick easy coats of acrylic wall paint cover the black shielding paint.

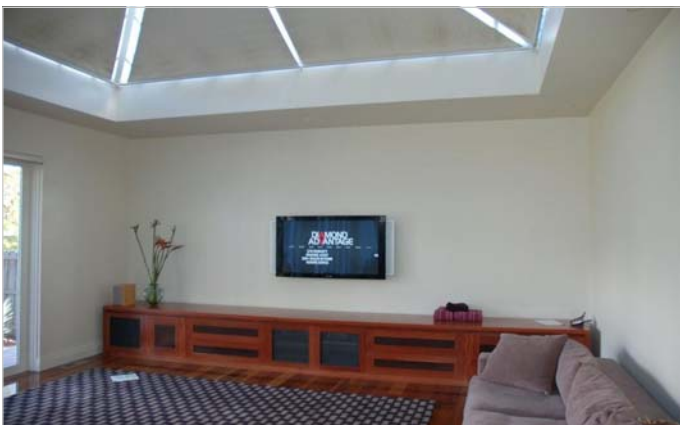
9) Finished family room.

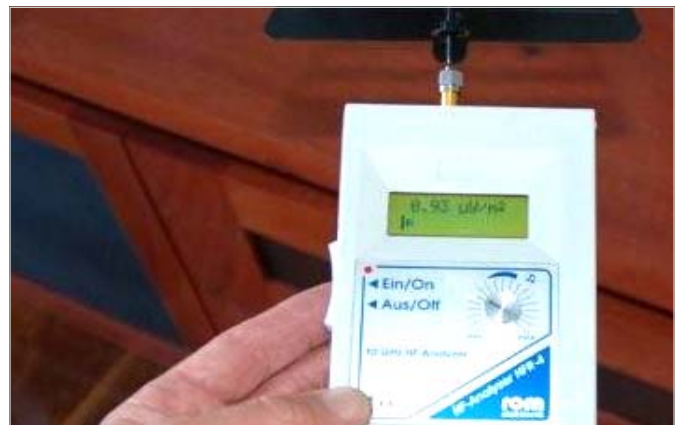
10) Excellent low reading of 0.93 microwatts per metre squared after shielding.

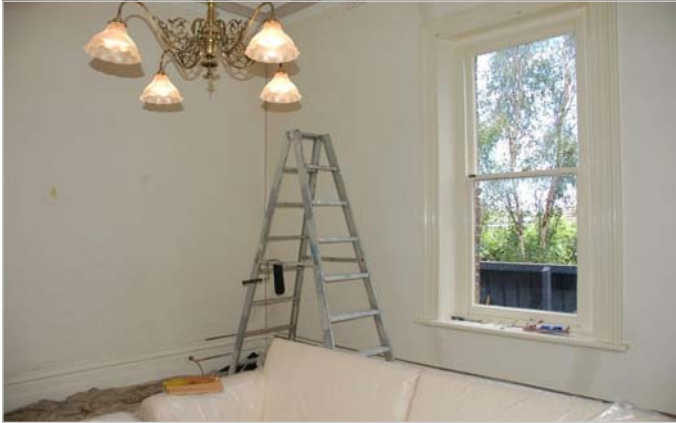
1) Playroom before shielding.

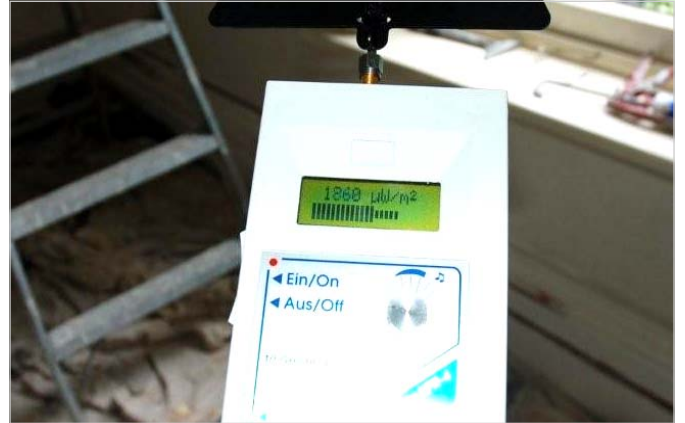
2) Very high EMR reading of 1860 microwatts per metre squared prior to shielding.

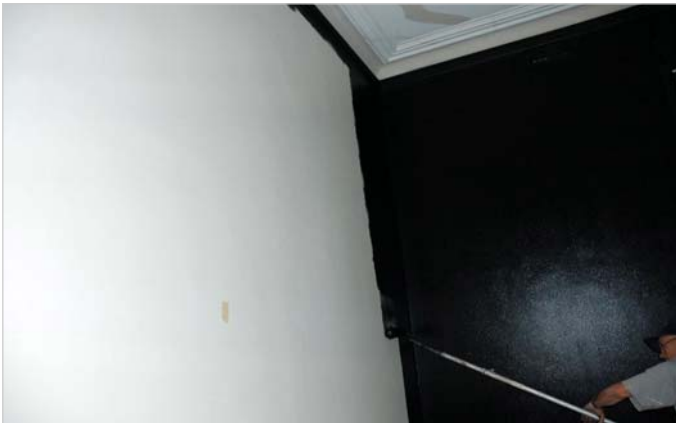
3) Shielding paint HSF-54 is applied.

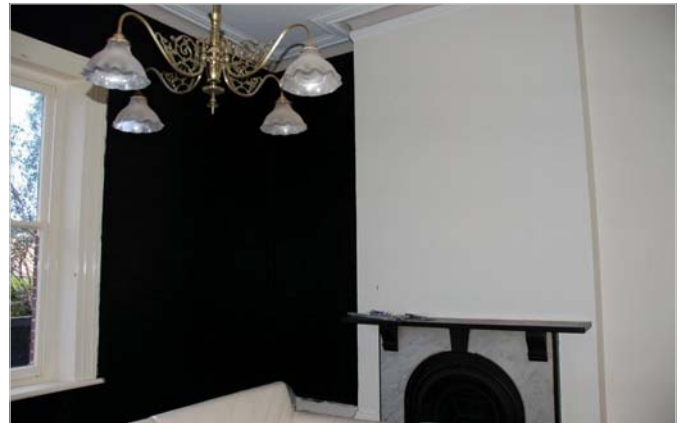
4) Affected parts of playroom shielded.

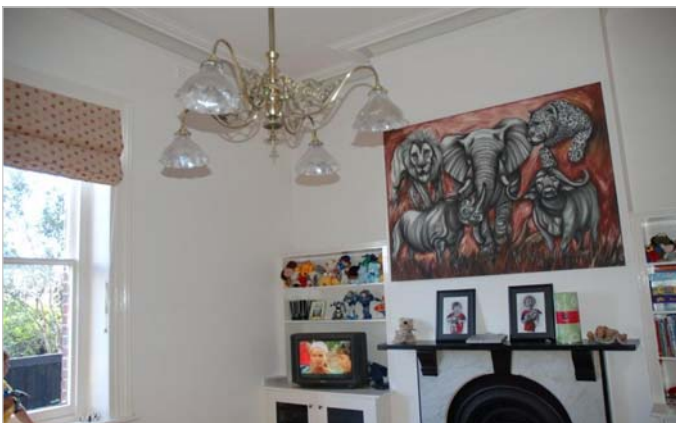
5) Finished over painted playroom.

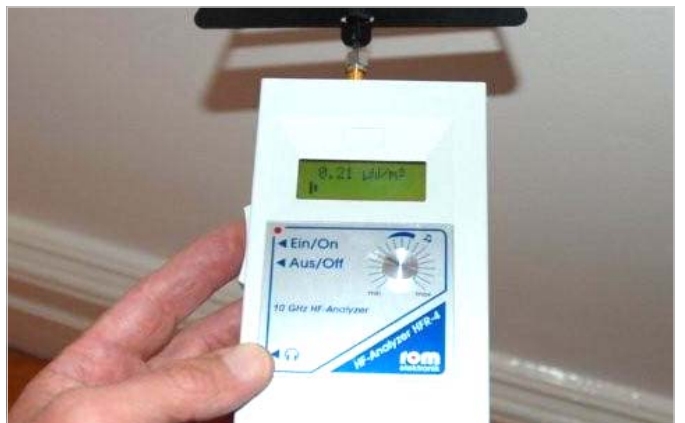
6) Fantastic low reading of 0.21 microwatts per metre squared achieved in shielded playroom.

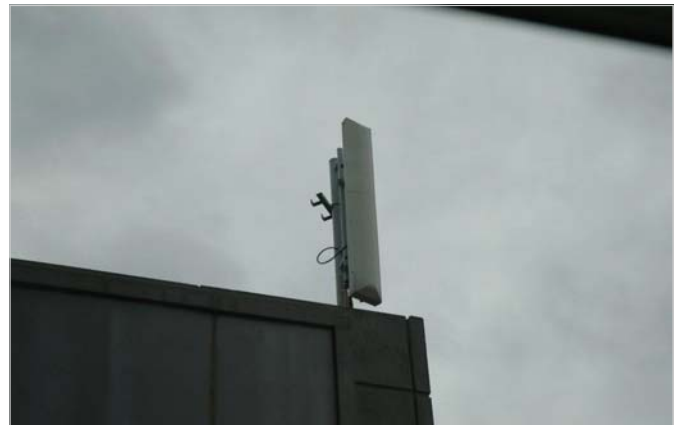
2) One mobile phone panel only 7m from the office window.

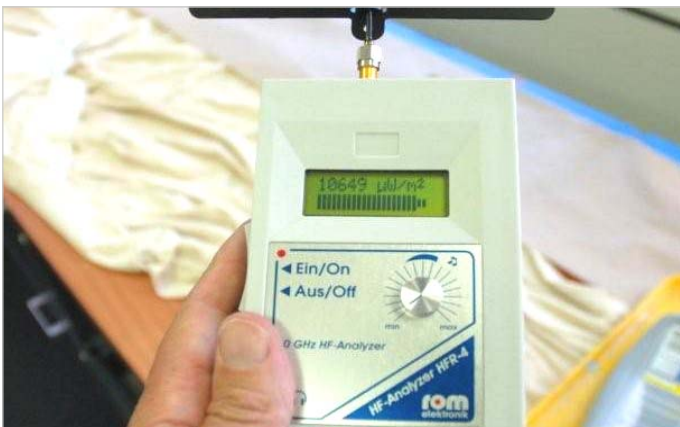
3) Extremely high reading of 10649 microwatts per metre squared before shielding.

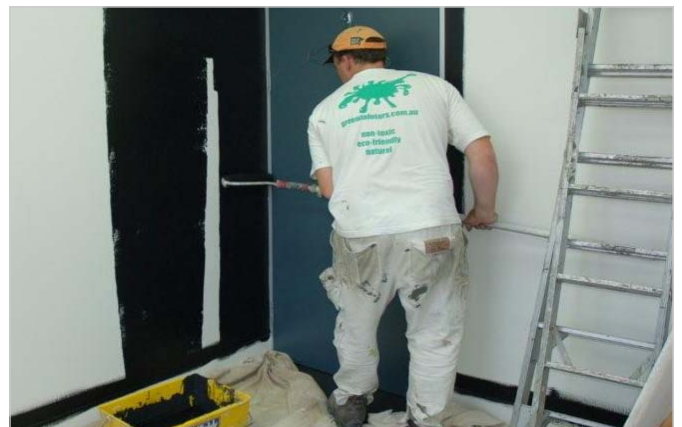
4) Member of Green painters gets to work applying shielding paint.

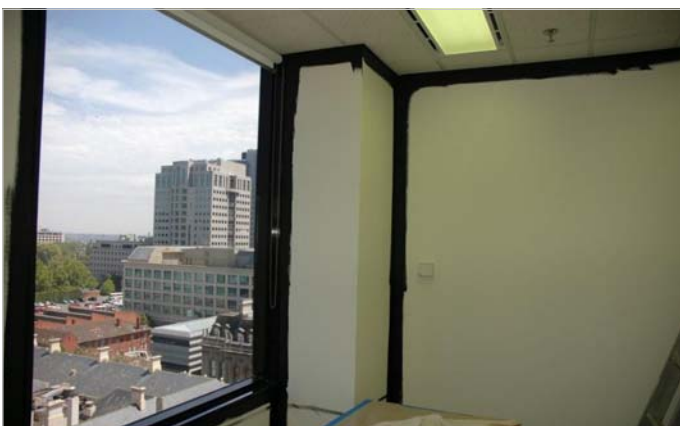
5) Shielding paint being applied.

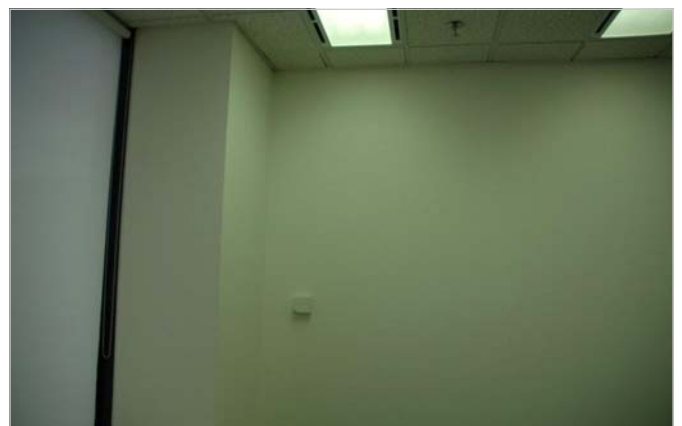
6) Finished shielded office after overpainting.

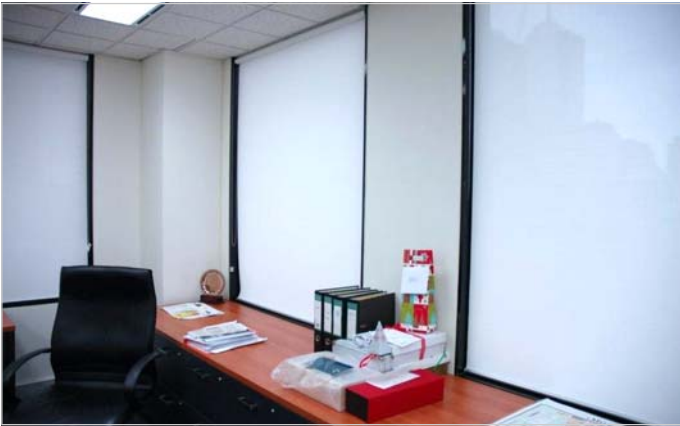
7) Completed over painted office with shielded window using Eco 30 shielding fabric.

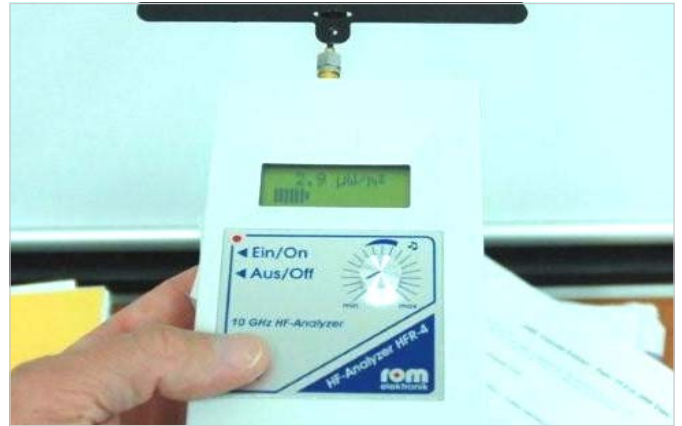
8) Very low reading of 2.9 microwatts per metre squared after shielding.

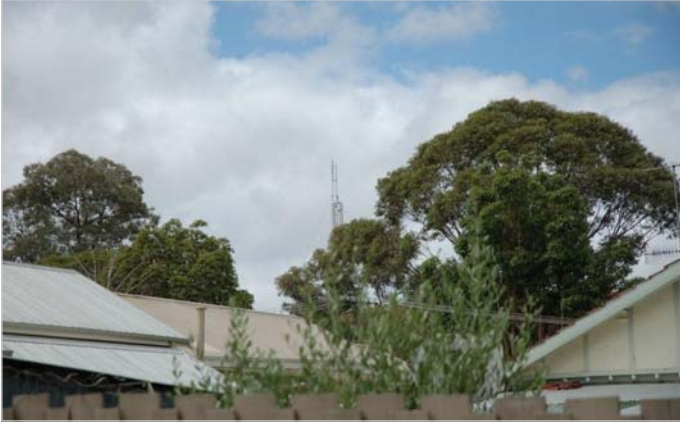
1) Mobile phone tower viewed from back yard of family home.

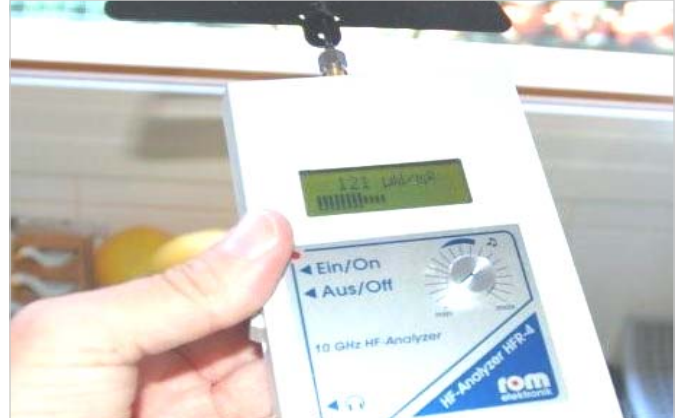
2) High reading of 121 microwatts per metre squared inside family kitchen.

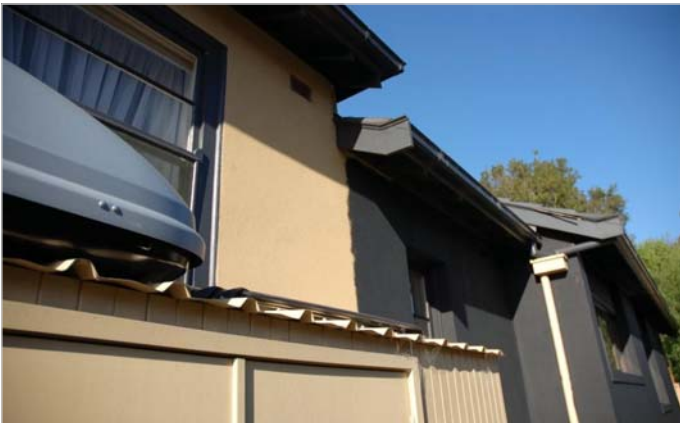
3) Back part of house now shielded on the outside, only in affected areas.

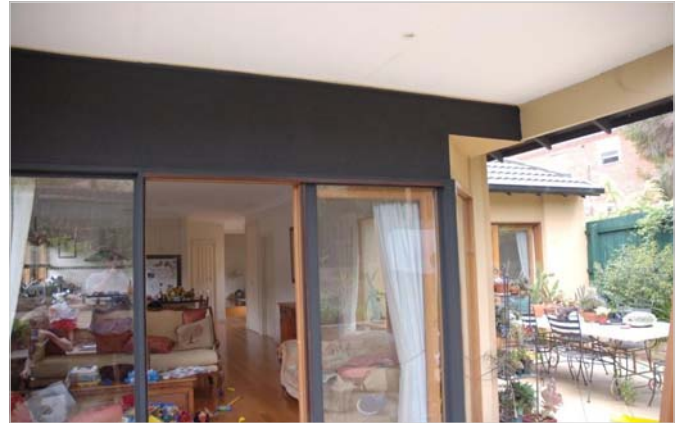
4) Back part of home shielded.

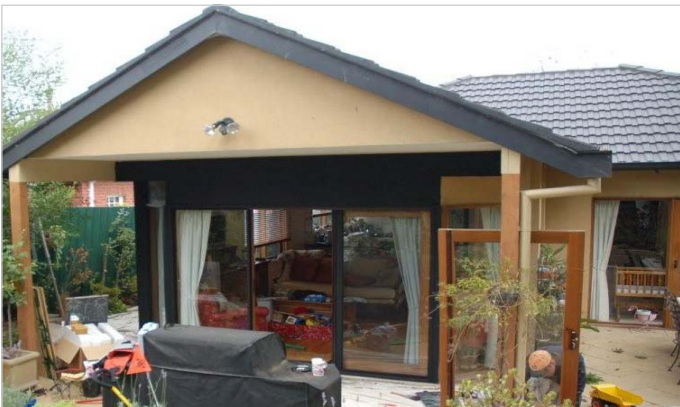
5) Over painting in progress.

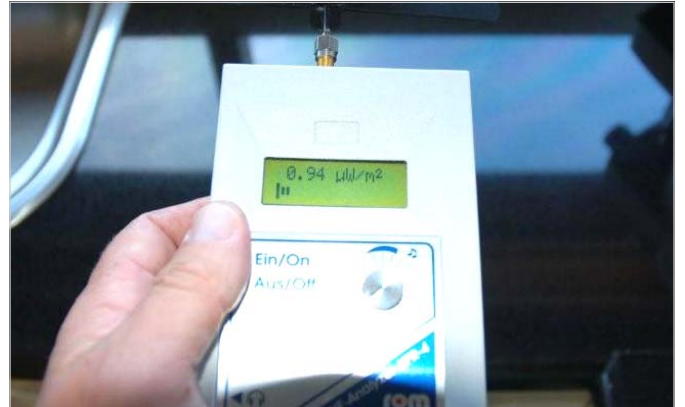
6) Readings now very low at only 0.94 microwatts per metre squared in the kitchen.

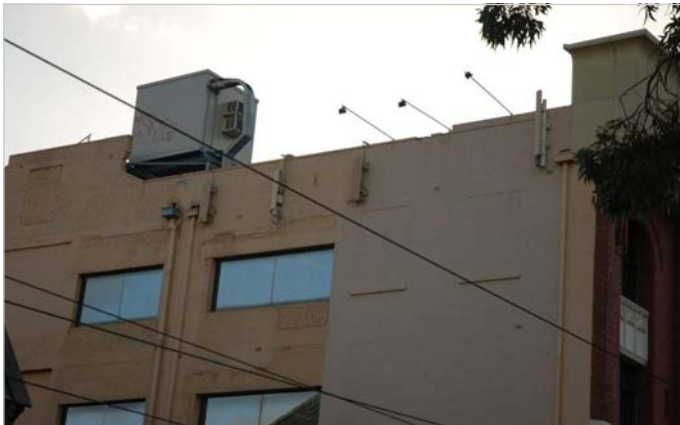
1) This top floor office is surrounded by mobile phone panels, four on the outside of the office wall and one by the window arch.

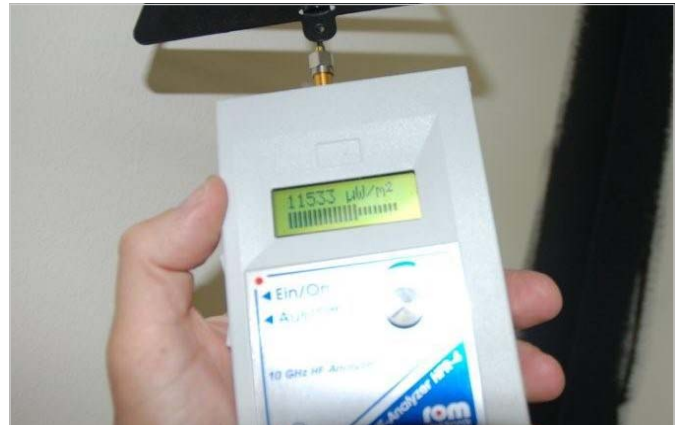
2) The meter reading on the inside of the small office is extremely high, with a reading of 11533 microwatts per metre squared.

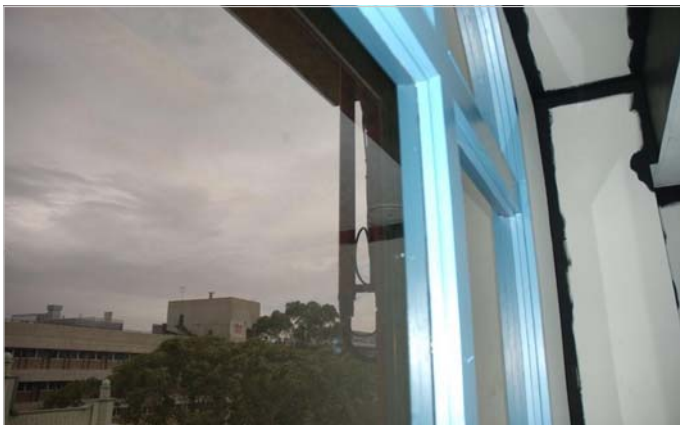
3) One of the mobile phone panels is right next to the window (see right hand side).

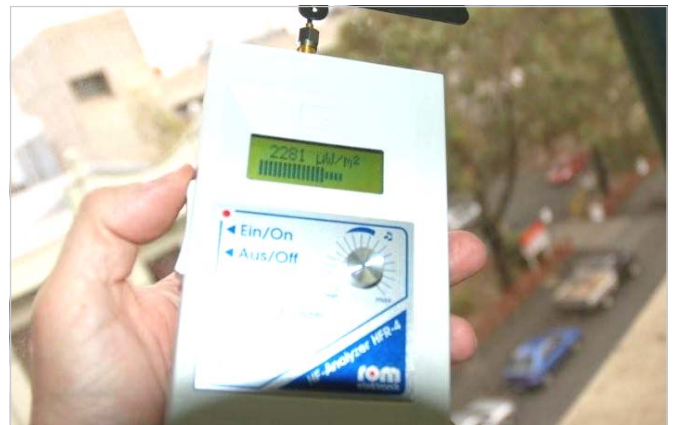
4) The meter reading next to the window is high at 2281 microwatts per metre squared.

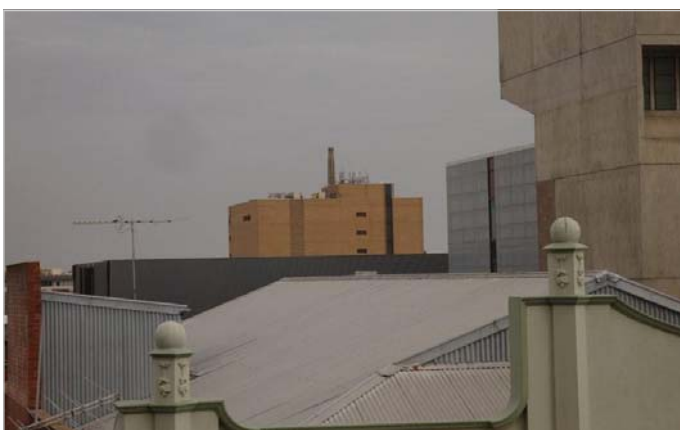
5) To make a difficult situation worse, there are also mobile phone towers on an adjacent building adding to the EMR.

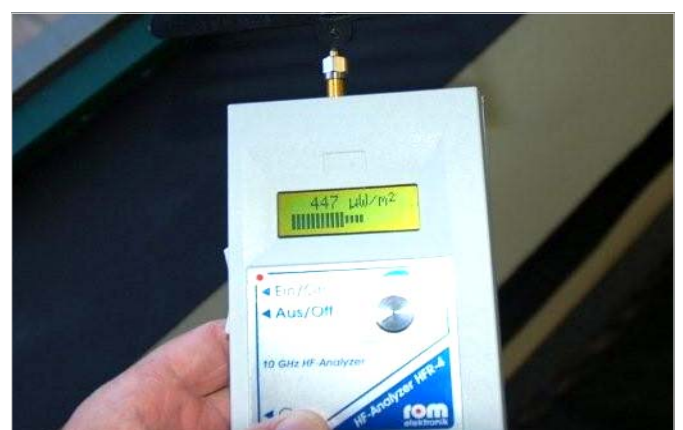
6) The larger office also records a high reading of 447 microwatts per metre squared.

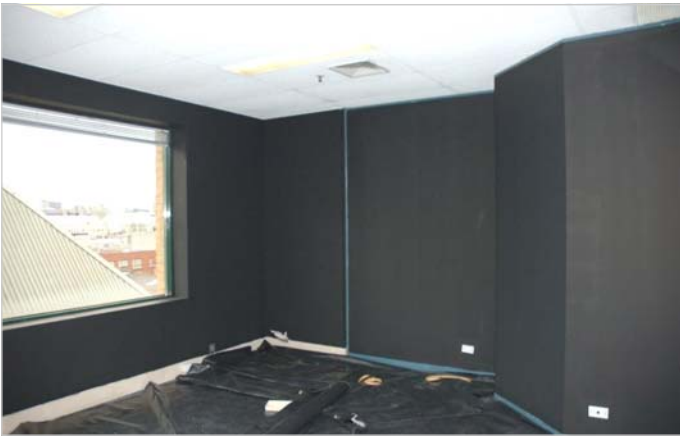
7) The larger office walls shielded with YSHIELD paint, before being overpainted.

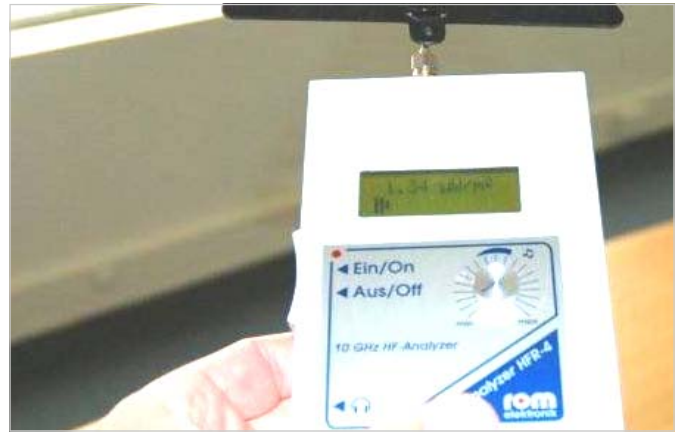
8) Now shielded, meter reading in the larger office is down to only 1.34 microwatts per metre squared.

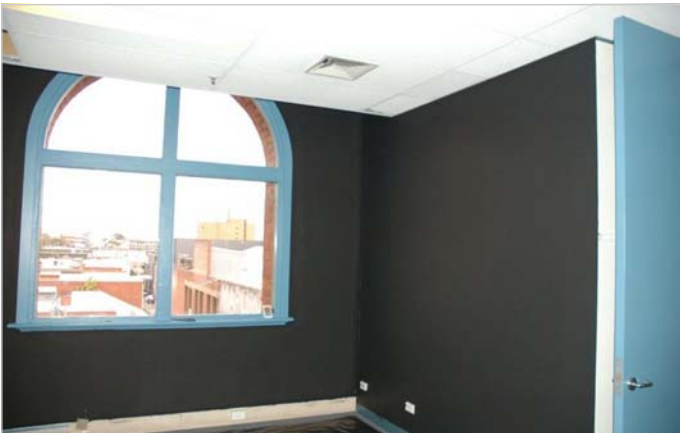
9) The smaller office walls shielded with YSHIELD paint.

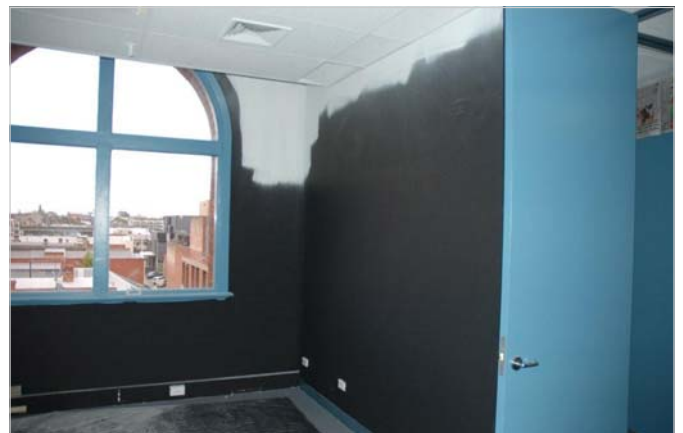
10) The smaller office starts to be over painted after shielding.

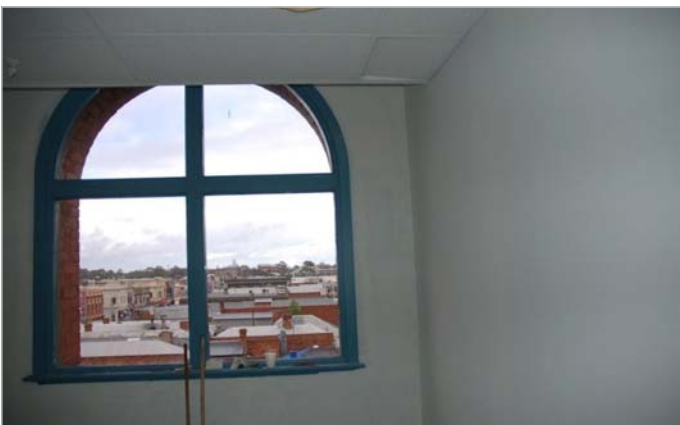
11) The smaller office now over painted.

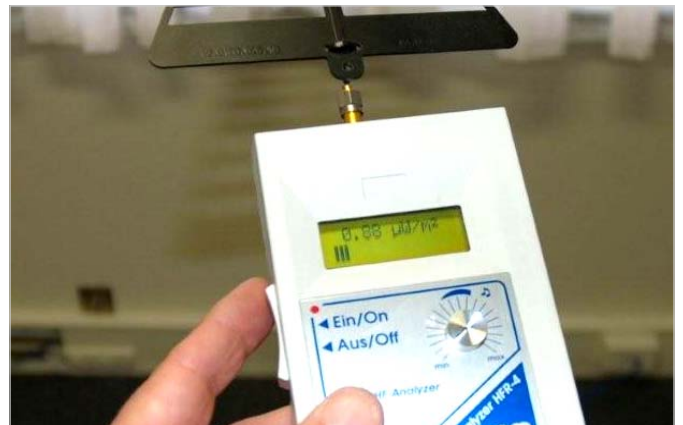
12) After shielding with Eco 30 Shielding fabric, meter reading is down to a tiny 0.88 microwatts per metre.

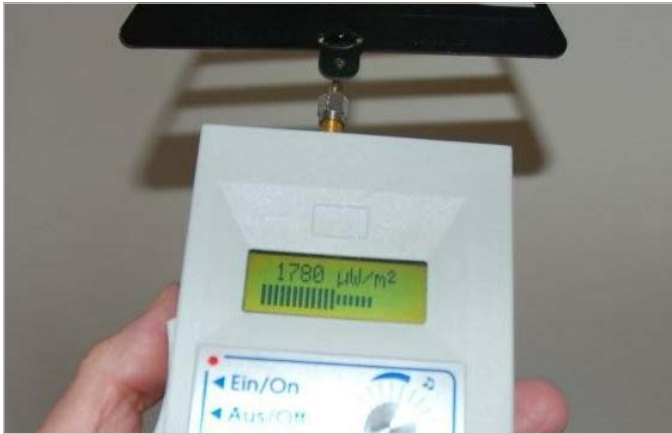
1) High reading of 1780 microwatts per metre squared next to interior bedroom window prior to shielding with paint and curtains.

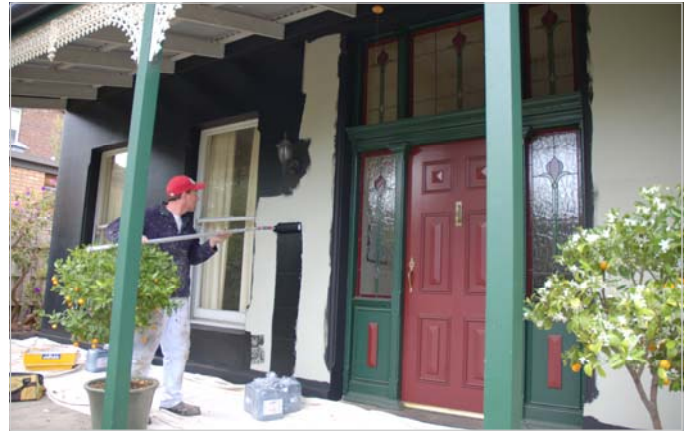
2) Exterior of home is painted with HSF 54 shielding paint.

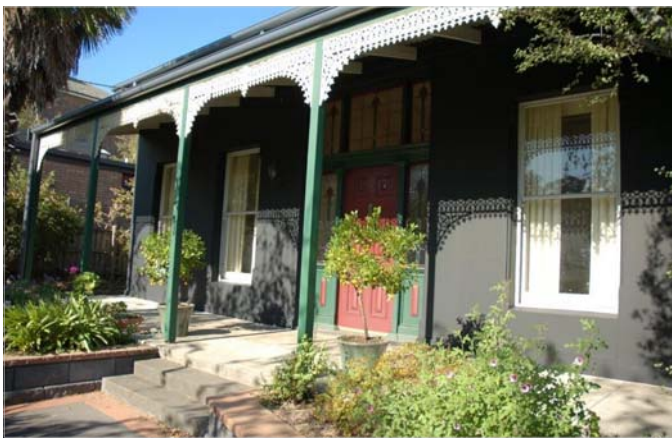
3) Front of the house entirely shielded.

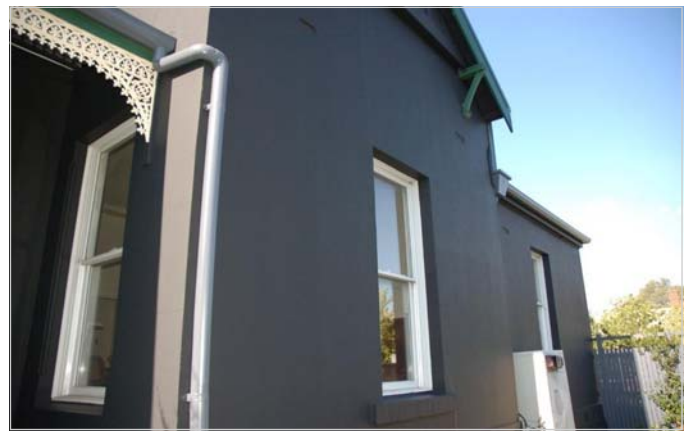
4) The side of the house is also painted with HSF 54 shielding paint and fully shielded.

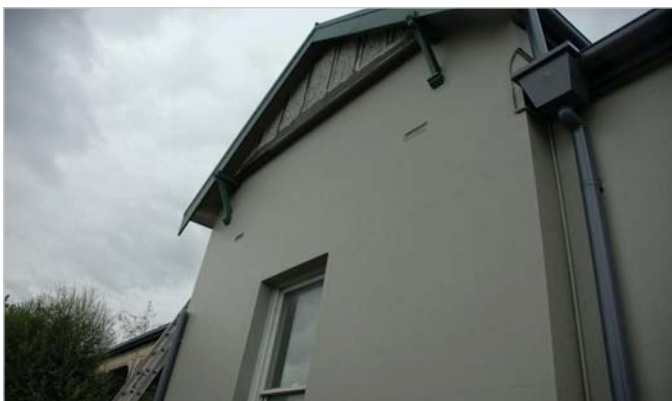
5) The side of house in the process of being over painted.

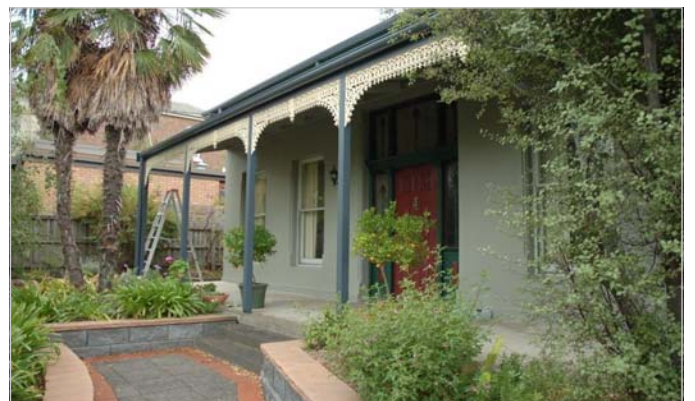
6) Front of house over painted and shielding complete.

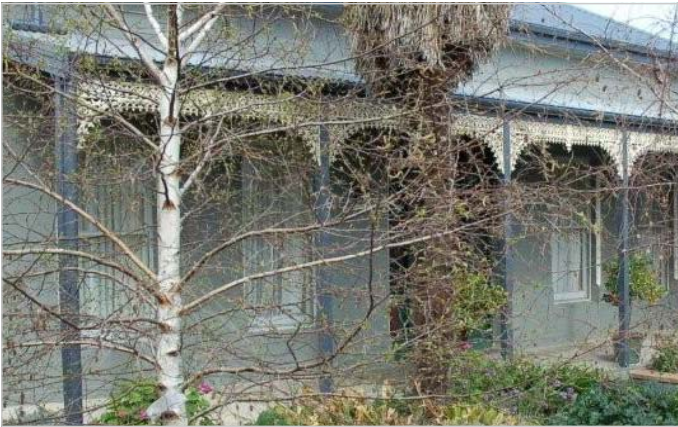
7) Eco 30 shielding fabric curtains are hung at the bedroom windows.

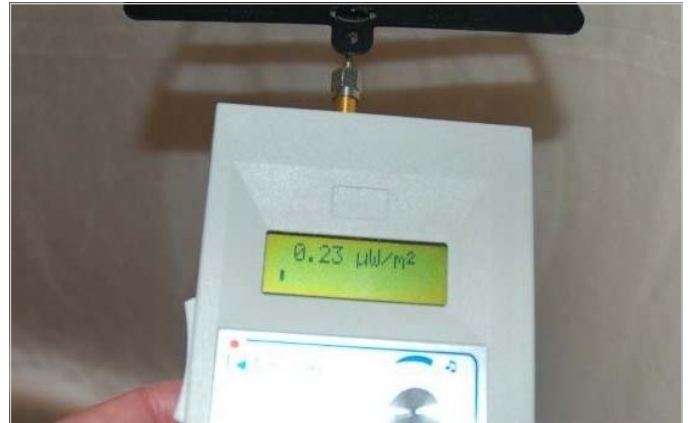
8) Very low reading of only 0.23 microwatts per metre squared taken next to interior bedroom window after shielding paint and curtains.

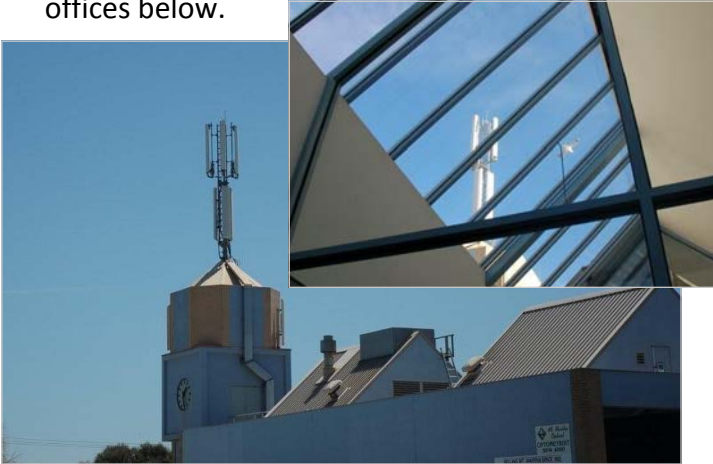
1) Bank of mobile phone towers loom over shopping centre beaming through glass roof into first floor offices below.

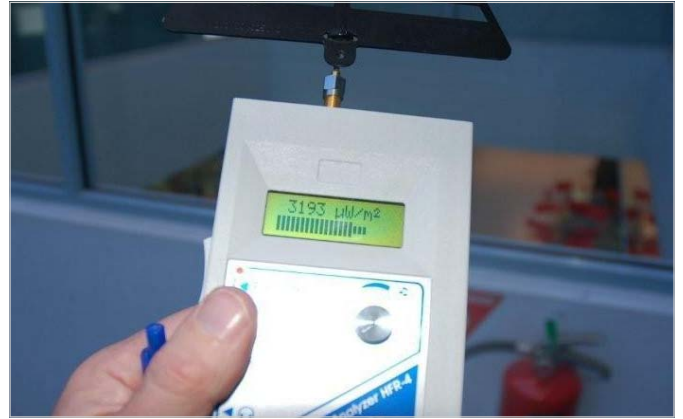
2) High meter reading (3193 microwatts per metre squared) in corridor outside office to be shielded.

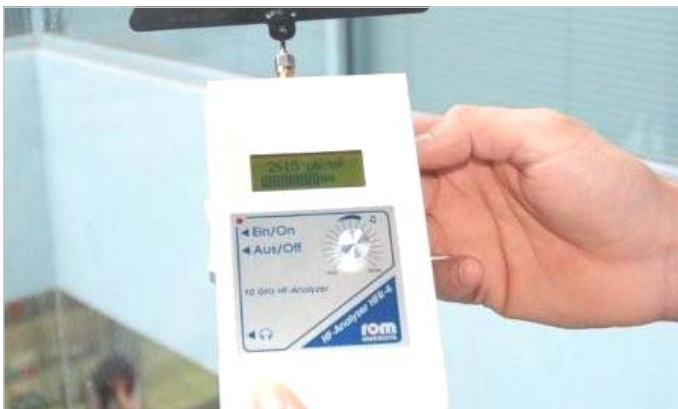
3) High meter reading of 2615 microwatts per metre squared inside office before shielding.

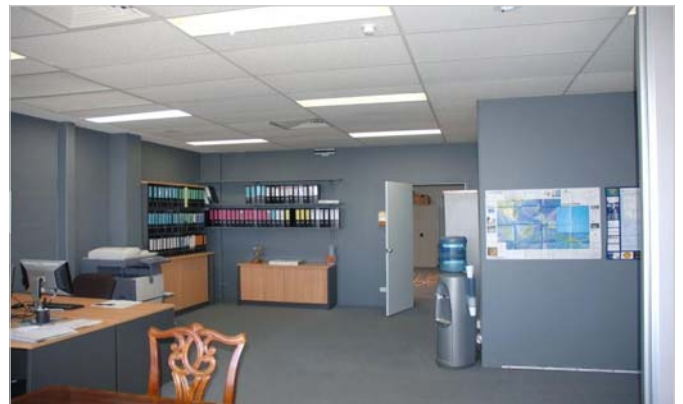
4) Inside of main office pre-shielding.

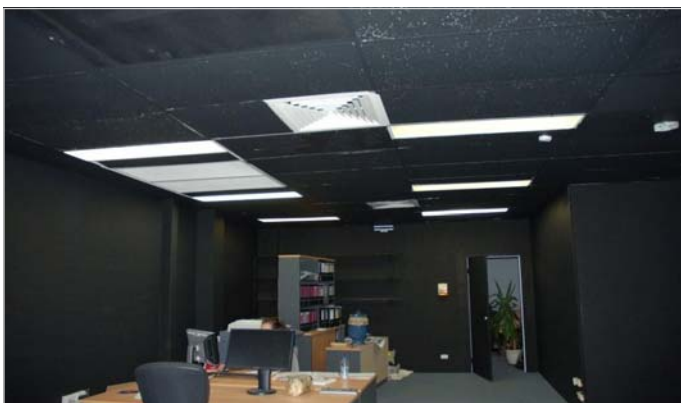
5) Main office totally shielded with HSF-54 Shielding paint.

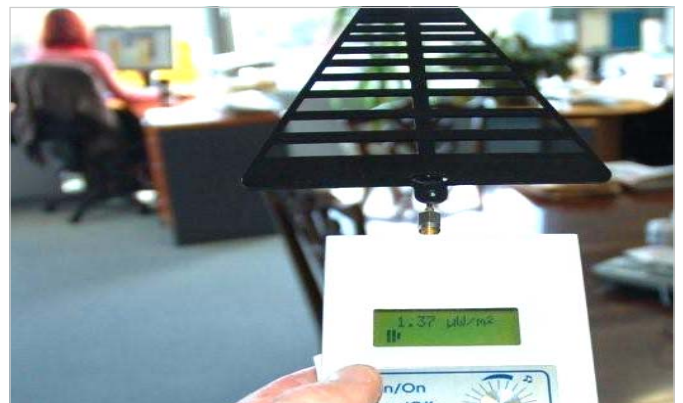
6) Over painted office now showing very low reading after shielding of 1.37 microwatts per metre squared.

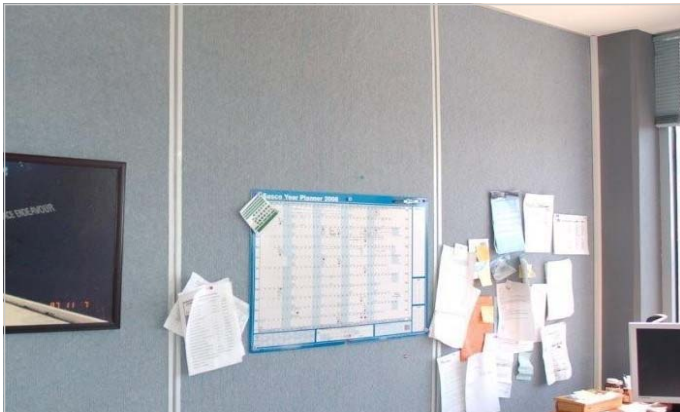
7) Adjoining office with `carpet style` partitions, not suitable for shielding with paint. Readings were several thousand microwatts per metre squared. A potential problem for shielding.

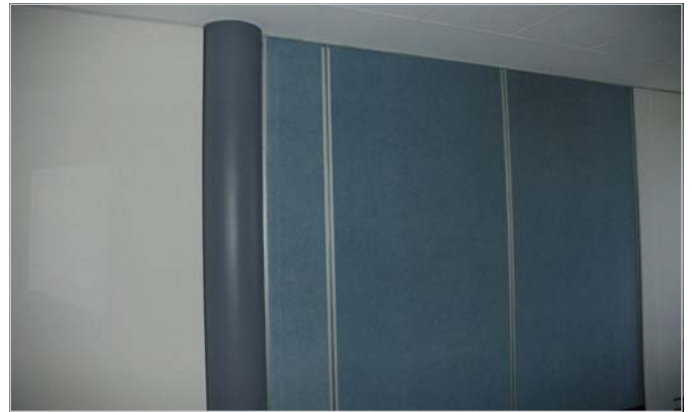
8) The solution: Partition boards are framed in shielding fabric (white areas) and screwed on top of existing partition wall.

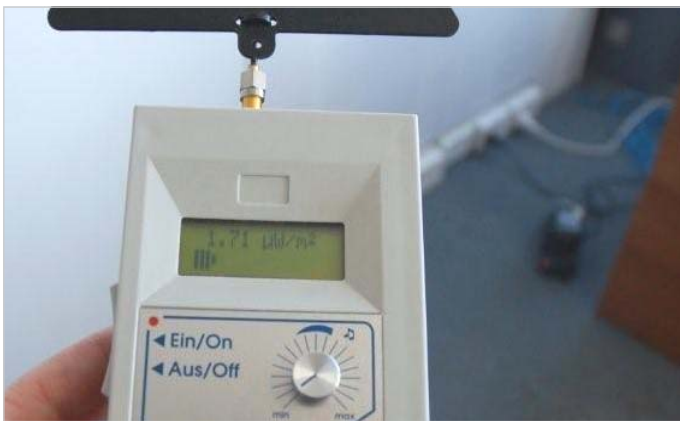
9) New fabric shielded partition wall in place with now very low readings of only 1.71 microwatts per metre squared.

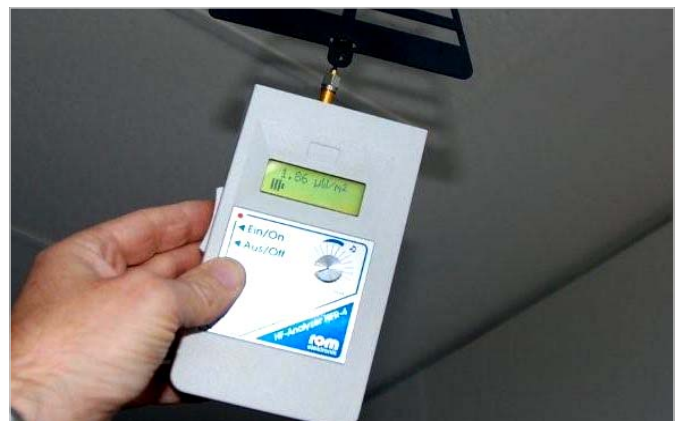
10) Ceiling in same office (with new partition wall) shielded with HSF-54 paint and over painted. Now very low readings of only 1.86 microwatts per metre squared.
